Technical Information

Assessment of lining ruptures

Assessment/evaluation of cracks and ruptures in the lining layer of disc brake linings

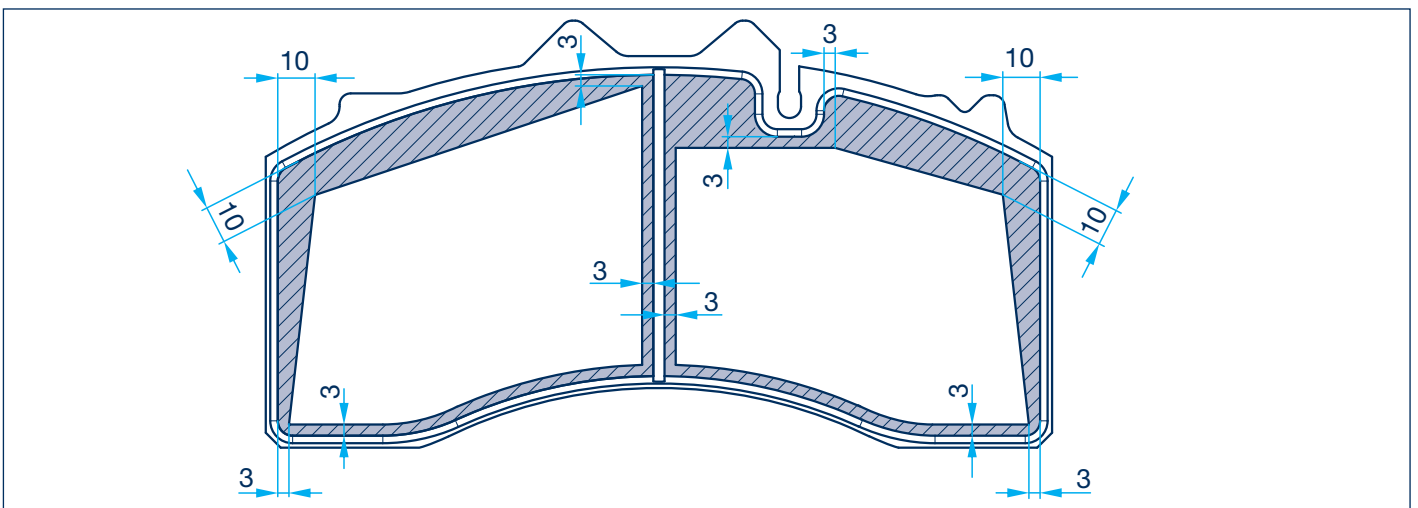
The defined areas shown in Figure 1 may display ruptures to the edges under the following conditions:

- Ruptures are only permissible in the edge areas marked (3 mm from the peripheral edges and the central groove and a maximum of 10 mm to the upper lining corners).
- The ruptures are no larger than shown in Figure 1.
- The total rupture surface is no larger than 10% of the total lining surface.
- The ruptures, as shown in Figure 2, are not in the area of the lining connection (2 mm distance from the lining's backing plate).
- There are no ruptures in other areas.

The ruptures shown above do not signify a defective product but instead are a sign of normal wear. Therefore, a replacement of the linings is not yet necessary.

Figure 1: Permissible areas for edge ruptures are marked, but must be no more than 10% of the lining surface.

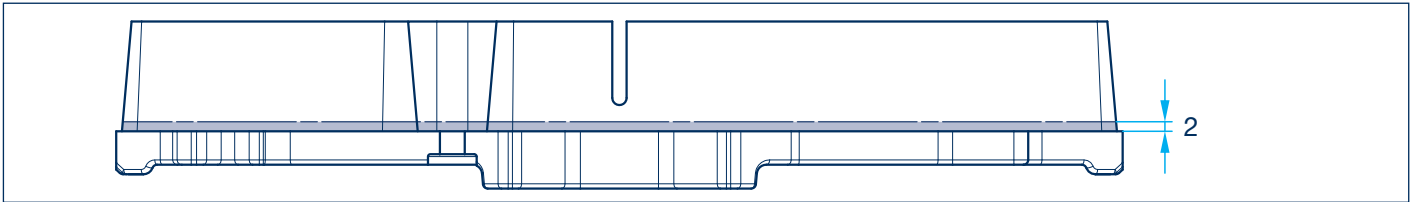
Figure 2: Protected area of the lining connection – no ruptures or stripping are permissible here.

- The cracks do not go all the way to the lining connection area (2 mm above the lining's backing plate), see Figure 2.
- The cracks do not run horizontal to the backing plate.

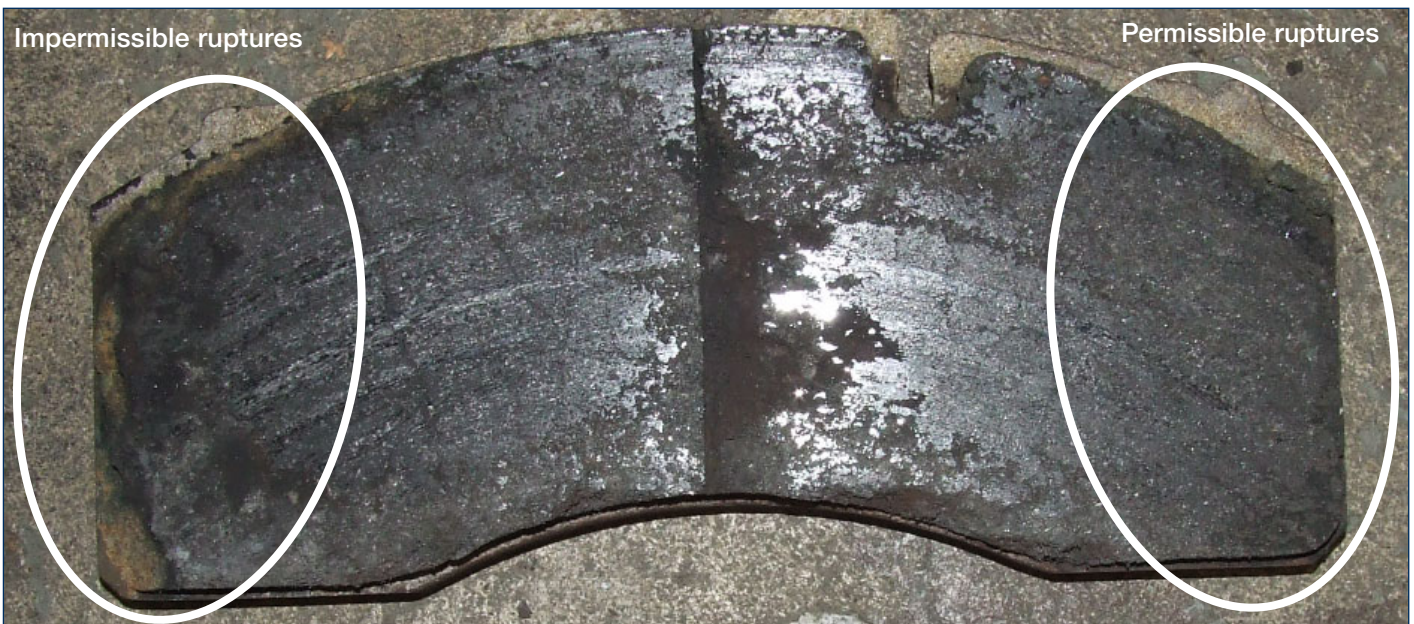
Figure 3 shows a comparison between permissible and impermissible edge ruptures.

Figure 3: Lining with impermissible

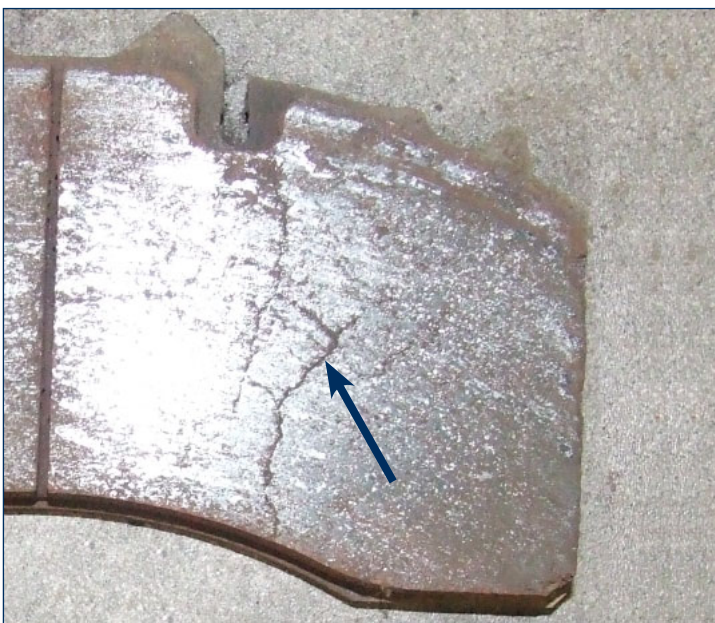
Figure 4: Cracks in the permissible area of the lining surface

The cracks in the lining surface shown in Figure 4 are acceptable under the following conditions:

The cracks shown do not signify a defective product but instead are a sign of normal wear. Therefore, a replacement of the linings is not yet necessary.
