NEWS Aftermarket

AM02 / 2017

Amendment of repair kits

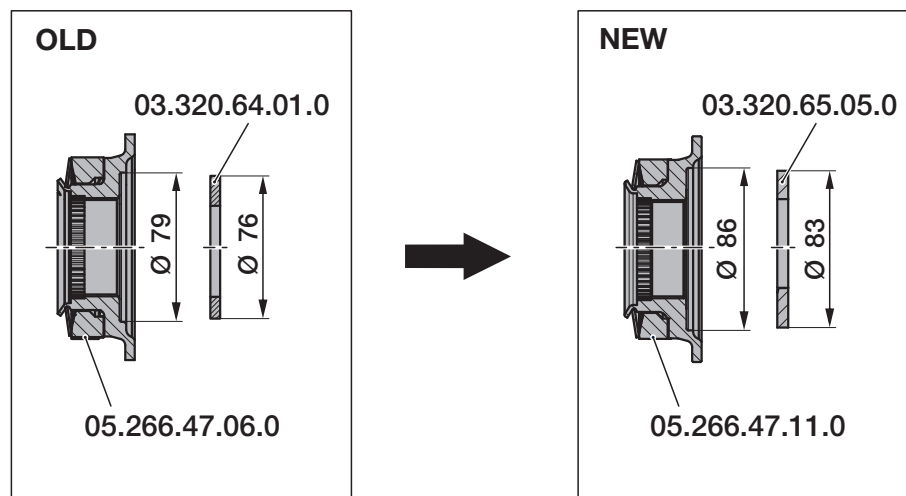
In 2014, the combination of axle nut 05.266.47.06.0 with thrust washer 03.320.64.01.0 has been replaced by the combination of axle nut 05.266.47.11.0 with thrust washer 03.320.65.05.0.

A different combination of axle nut and thrust washer as explained above is not permitted. Incorrect assembling may cause further damages!

To avoid incorrect assembling the a.m. new repair kits will not contain the thrust washer 03.320.64.01.0.
