TS2

Assessment of lining ruptures

Assessment/evaluation of cracks and ruptures in the lining layer of disc brake linings

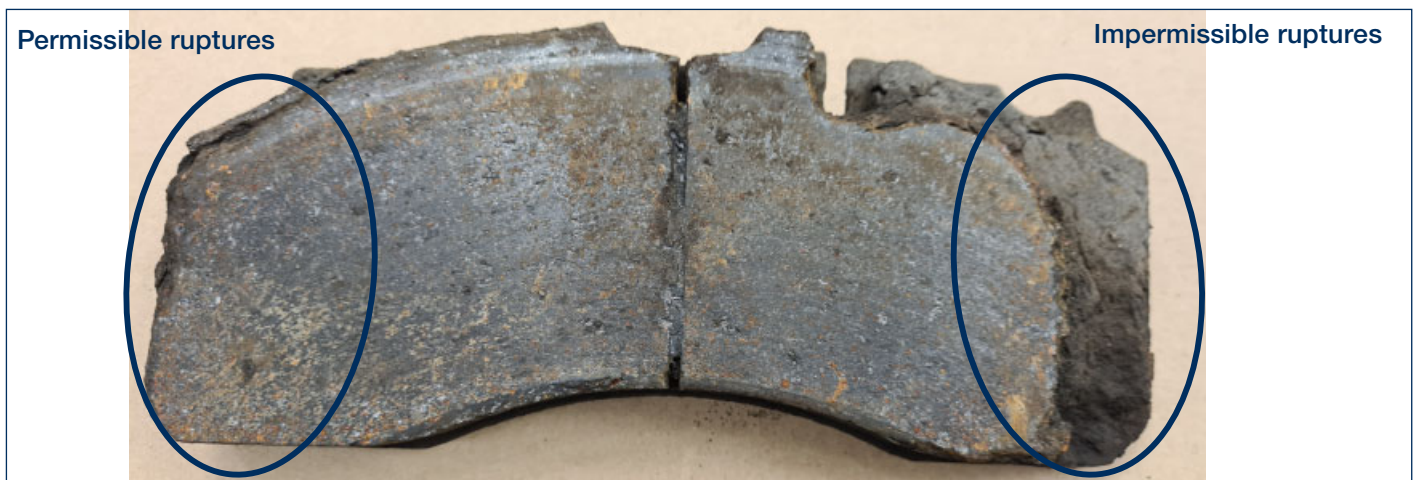
Figure 3: Lining with impermissible

Figure 3 shows a comparison between permissible and impermissible edge ruptures.

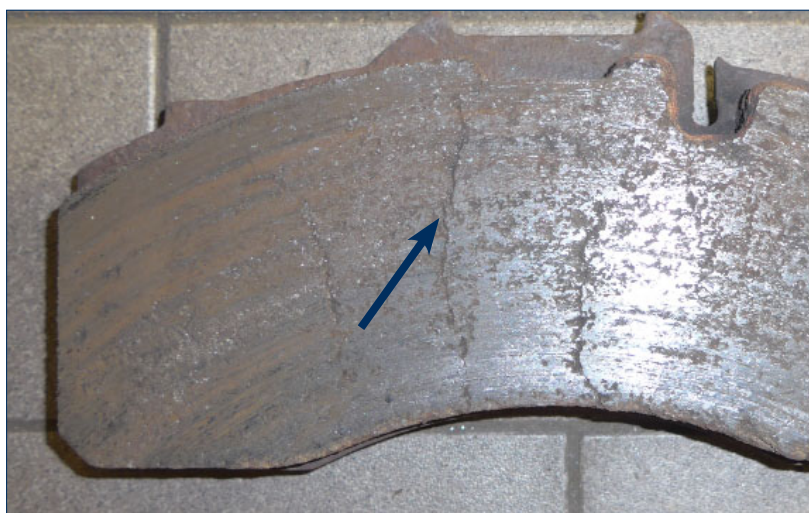
Figure 4: Cracks in the permissible area of the lining surface

The cracks in the lining surface shown in Figure 4 are acceptable under the following conditions:

- The cracks do not go all the way to the lining connection area (2 mm above the lining’s backing plate), see Figure 2.
- The cracks do not run horizontal to the backing plate.

The cracks shown do not signify a defective product but instead are a sign of normal wear. Therefore, a replacement of the linings is not yet necessary.

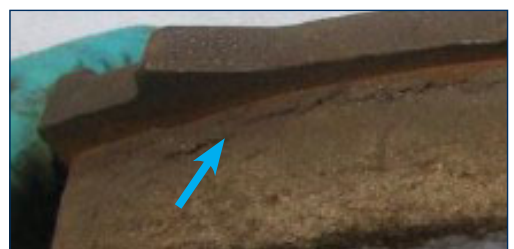
Figure 5, 6: Cracks running parallel to the backing plate are inadmissible
